Butternut Creek Watershed Assessment

Prepared for:
Upper Susquehanna Coalition
183 Corporate Drive
Owego, NY 13827
607.972.2348

By:
Otsego County Soil and Water Conservation District
967 County Hwy 33
Cooperstown, NY 13326
607.547.8337 Ext. 4

January 2021

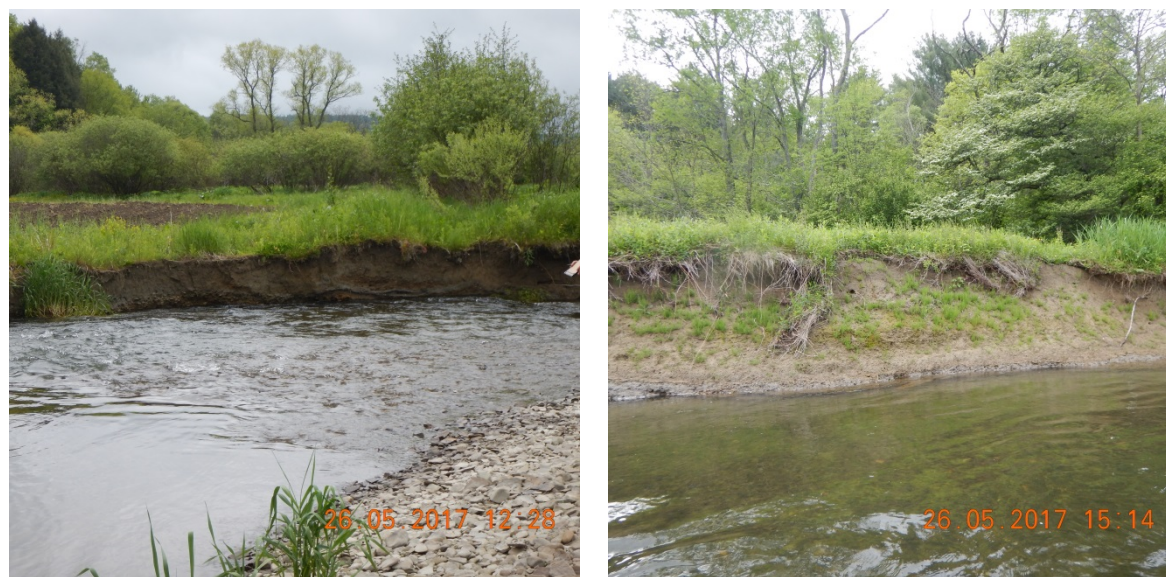
Figure 7. Left: An example of a site where Bank Erosion Potential was identified as Extreme through BEHI measurements. Right: The site is approximately 1.5 miles downstream and was noted for erosion and exposed bank but No BEHI measurements were taken. Both sites are in the Middle Butternut Creek watershed (Photo credits: Ed Lentz, 5/26/2017).

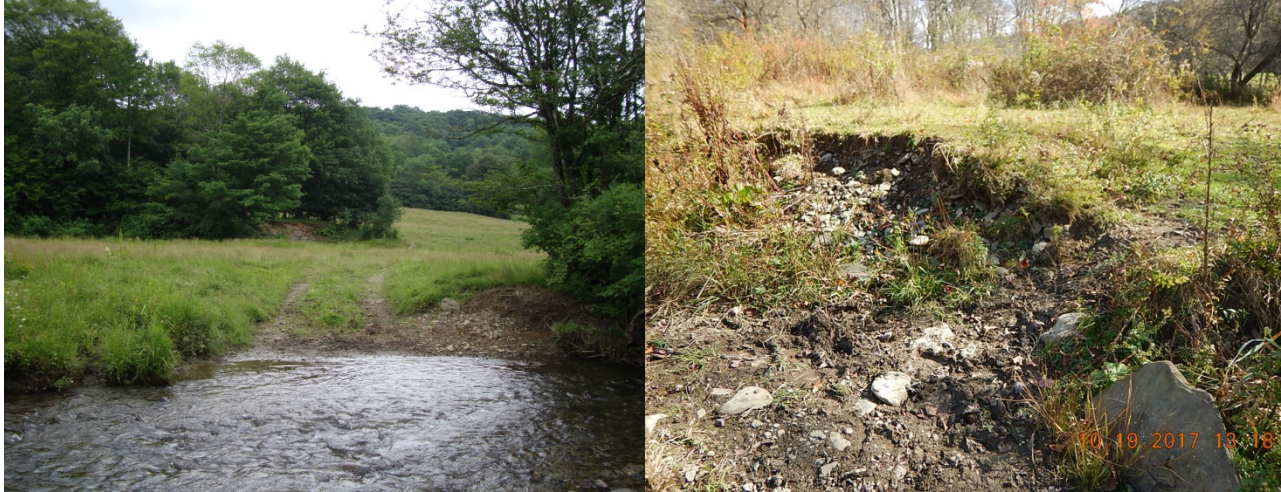
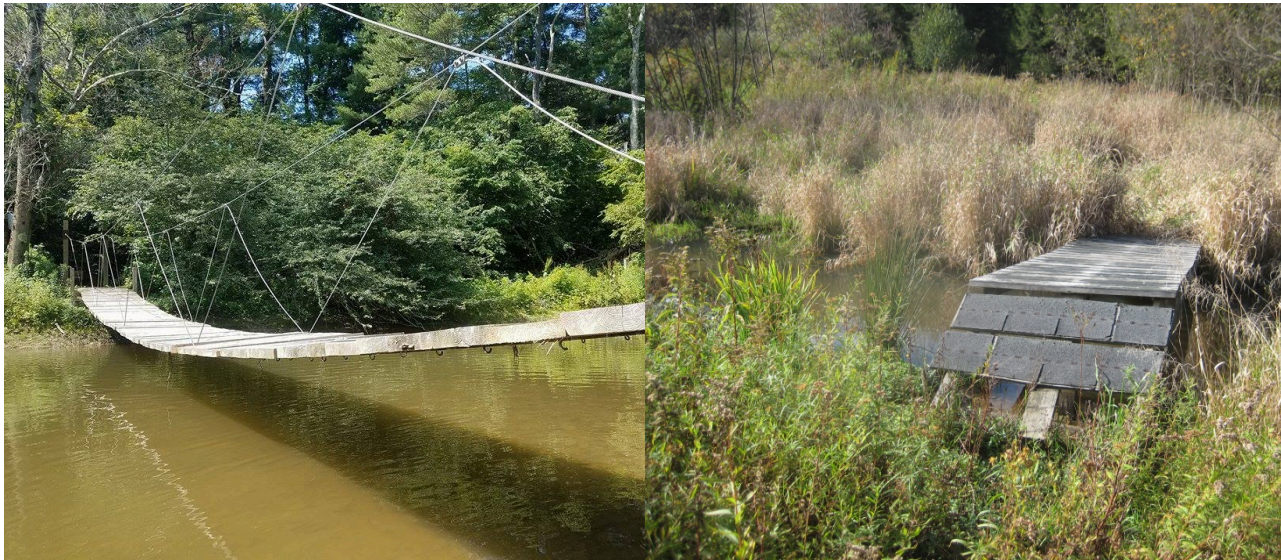
Figure 23. Upper Left: Ford across Butternut Creek in the Upper Butternut Creek watershed (Photo: OCSWCD, 6/30/2017), Upper Right: Livestock crossing on Stony Creek in the Middle Butternut Creek watershed (Photo: OCSWCD, 10/19/2017). Lower Left: Footbridge across Butternut Creek in the Middle Butternut Creek (Photo: OCSWCD, 7/16/2017), Lower Right: Footbridge or snowmobile bridge on Unnamed tributary - UB_025 (Photo: Ed Lentz, 10/12/2017).

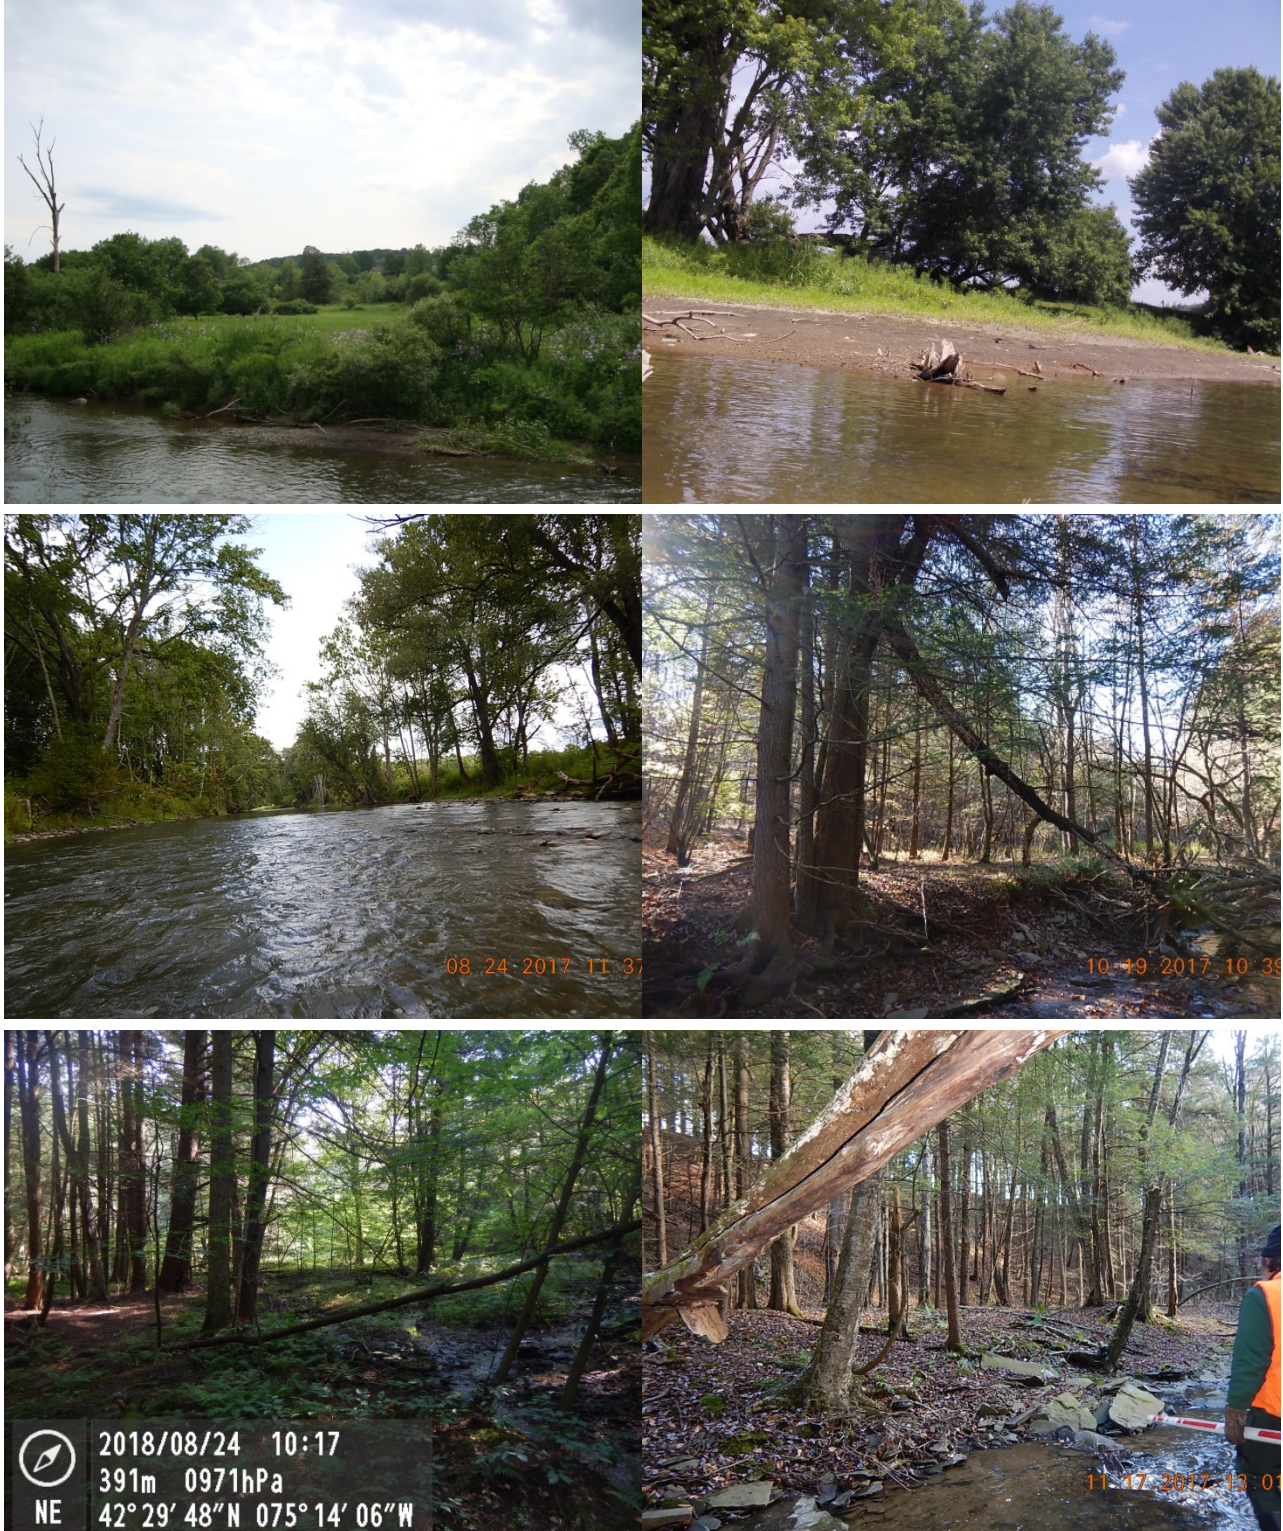
Figure 26. Floodplain Access - Upper Left: Upper Butternut Creek watershed mainstem (Photo: OCSWCD, 6/13/2017), Upper Right: Lower Butternut Creek watershed mainstem (Photo: OCSWCD, 8/9/2017), Middle Left: Lower Butternut Creek watershed mainstem (Photo: OCSWCD, 8/24/2017), Middle Right: Stony Creek (10/19/2017 – OCSWCD), Lower Left: Cahoon Creek (Photo: Tom Washbon and Maggie Brenner, 8/24/2018), Lower Right: Calhoun Creek (Photo: OCSWCD, 11/17/2017).

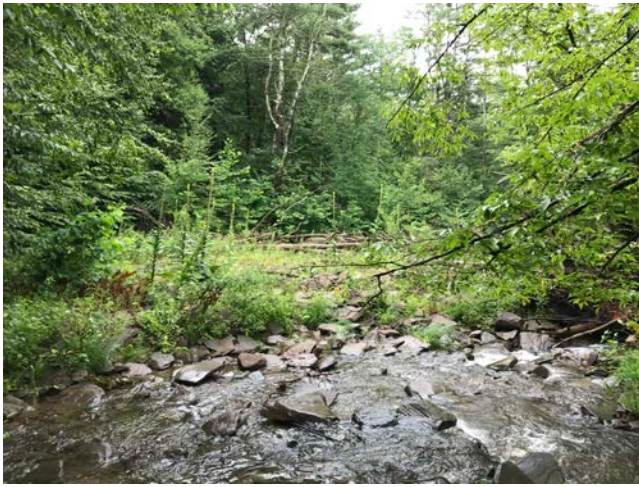
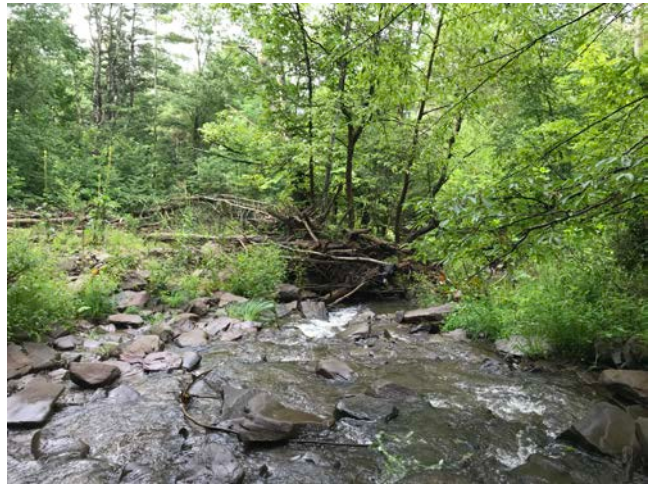
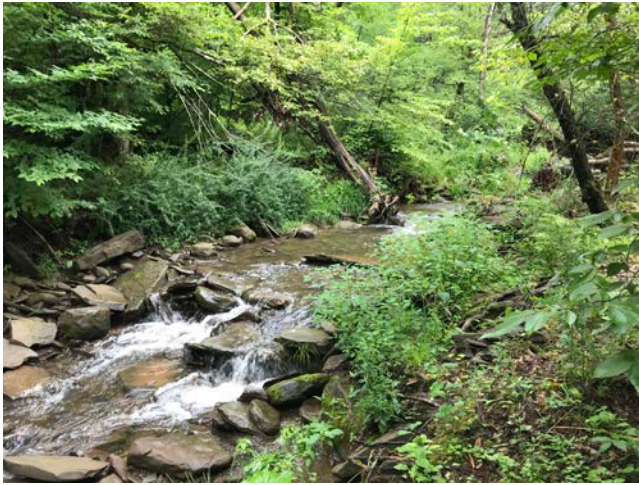
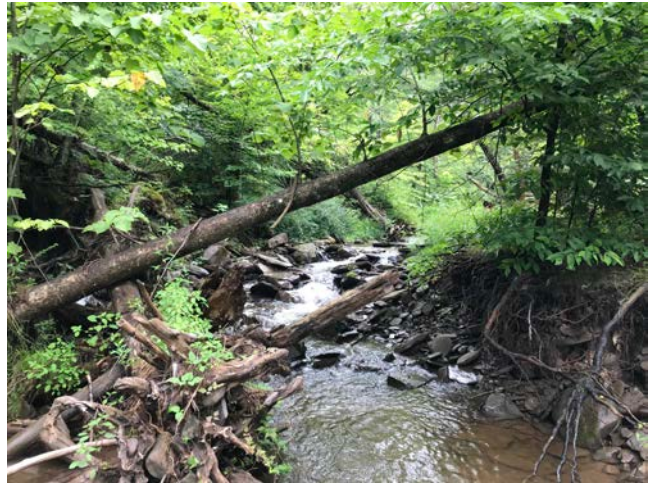
Dry Brook – Site 1

Site Observations – Upstream most site. Site is forested on right and left banks. It appears that during recent storm events, debris and gravel blocked the previous channel and a new channel has formed. The existing channel appears relatively stable even considering the steeper slope. Access is poor to get equipment or materials to the site.

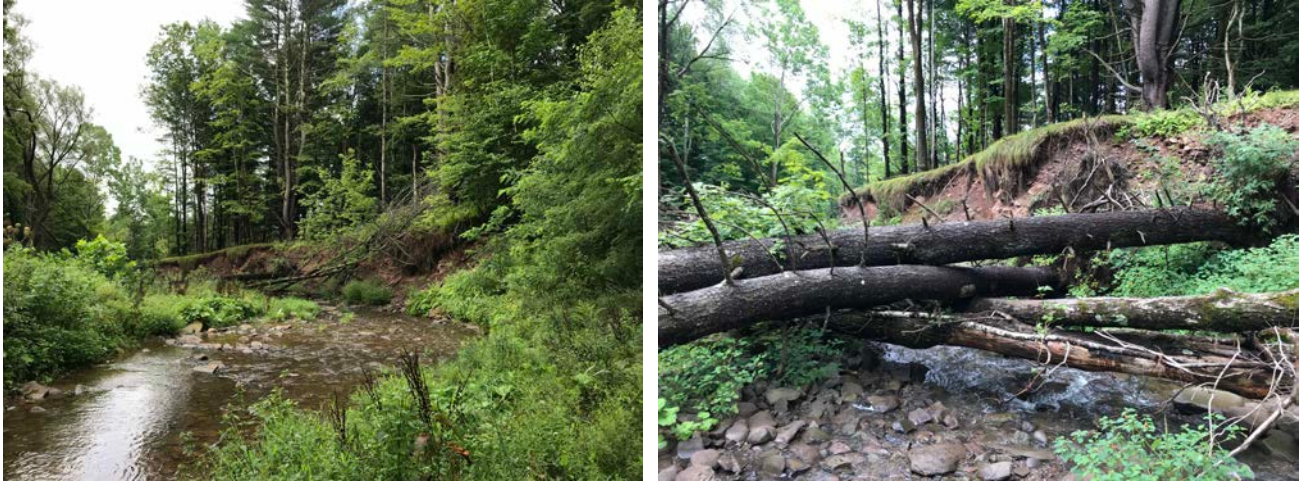
Dry Brook – Site 2

Site Observations – This site consists of a 15 foot high eroded right bank. The impaired reach is affected by debris and gravel accumulation and loose, unconsolidated soil.

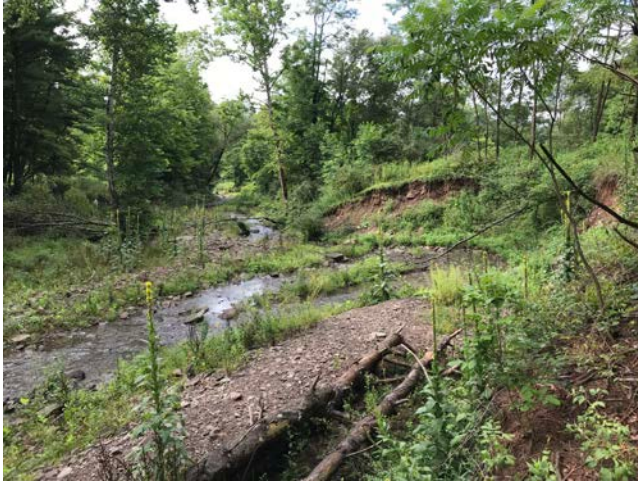
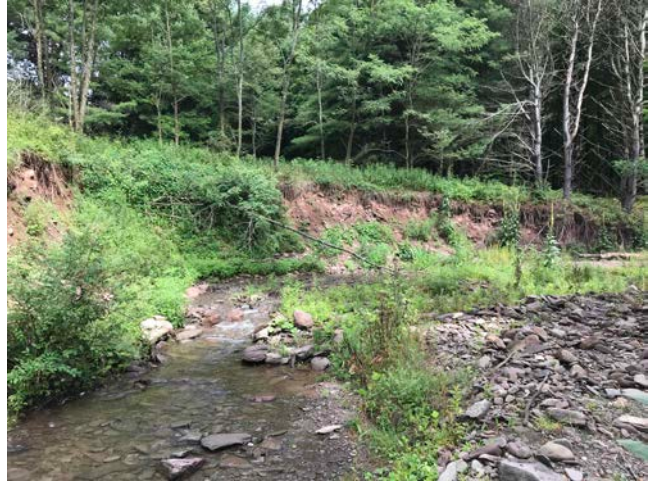
Dry Brook – Site 3

Site Observations – Gravel deposition has created a truncated meander and thalweg is near toe of high bank. Affected right bank is approximately 8-10 feet high, 60 feet in length, and consists of fine, unconsolidated material. Right and left banks are forested, however, root systems do not reach the toe of the slope.

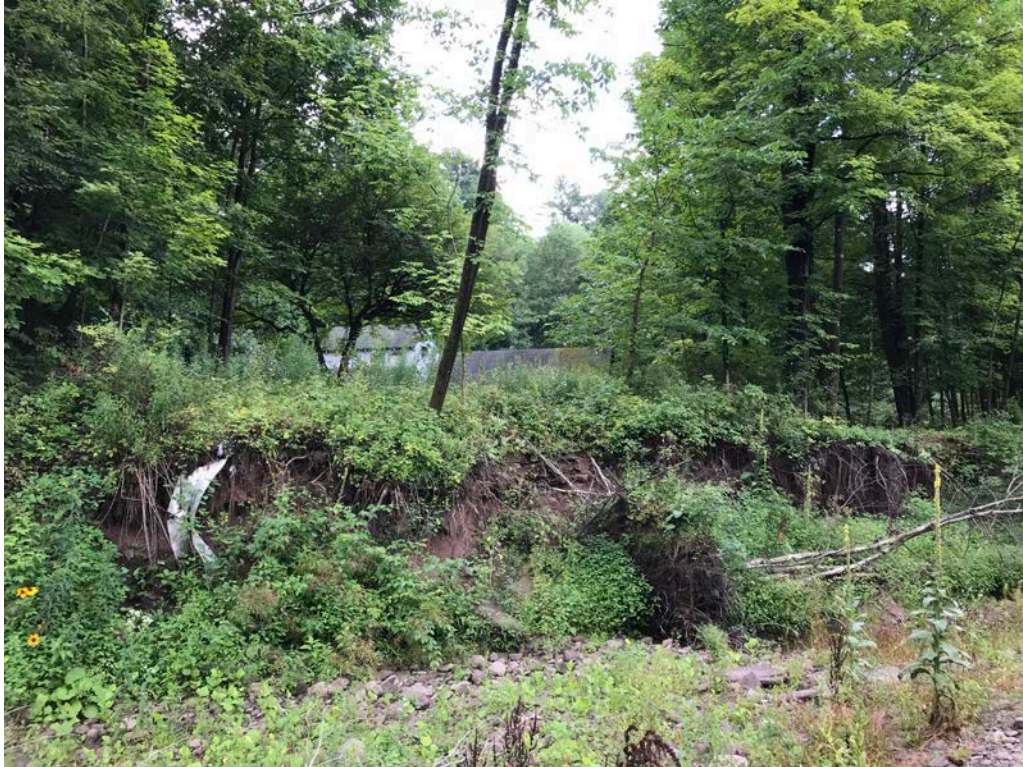
Dry Brook – Site 4

Site Observations – This site is a near vertical left bank approximately 10 feet high and 125 feet in length. The thalweg is concentrated toward the center of the channel with gravel side bars along the left and right.

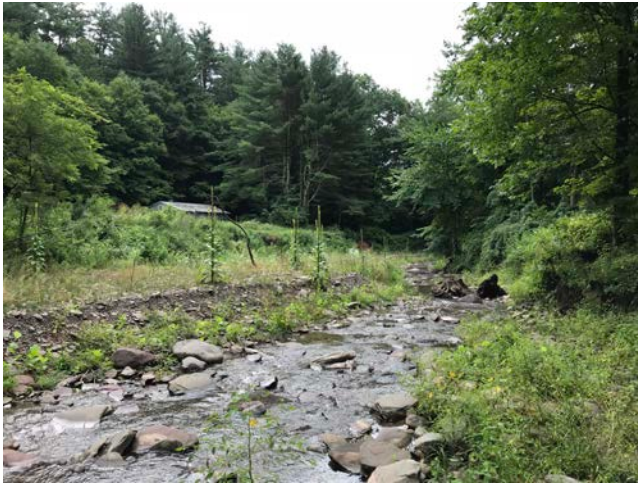
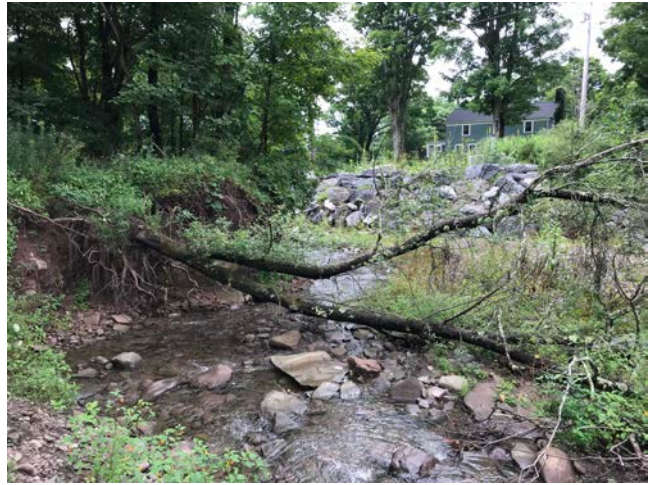
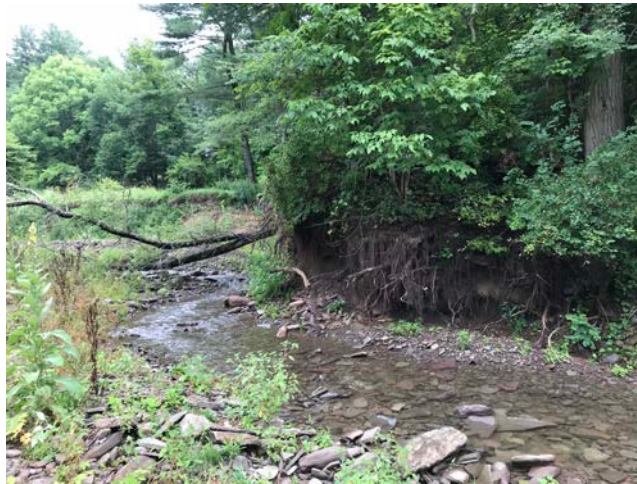
Dry Brook – Site 5

Site Observations – This is a fairly straight section with gravel deposition leading into a truncated meander. Previous channel work may have occurred after a prior storm event (i.e. channel straightening, gravel removal/gravel bench creation). Although a floodplain bench is evident, it may be too high to be engaged during a bankfull storm event. The site is approximately 200 feet in length and landowner has already tried to revegetate the gravel bench with trees and shrubs. Site access is good.

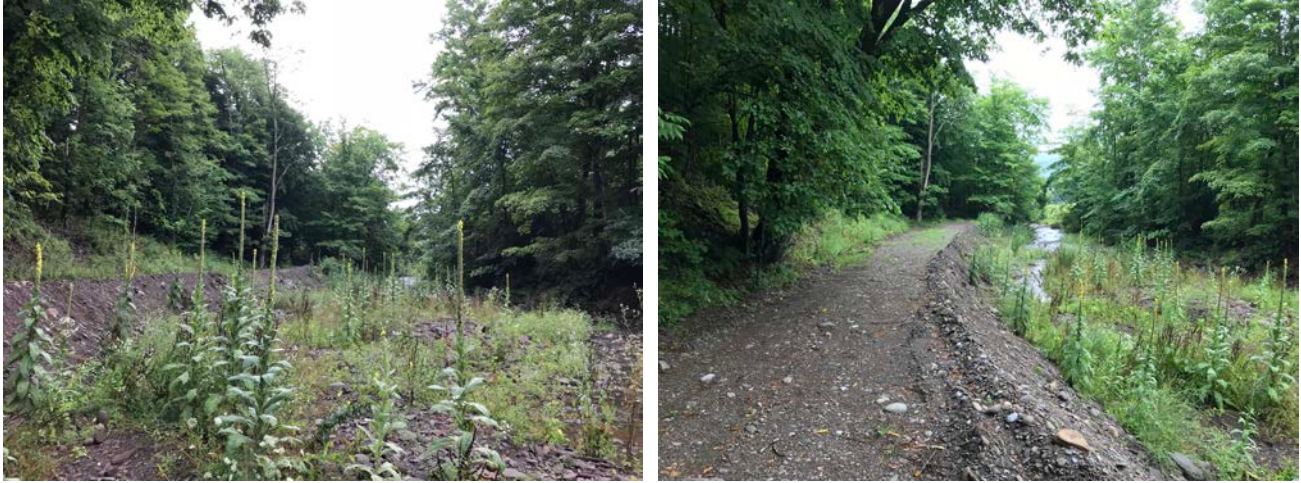
Dry Brook – Site 6

Site Observations – This site runs parallel to a driveway and previous storm events have washed the driveway out. Driveway has been filled and made passable. Stream is over-widened and gravel deposition is occurring in this reach. The site is approximately 250ft in length and the affected left bank is 6ft high. Site access is very good.

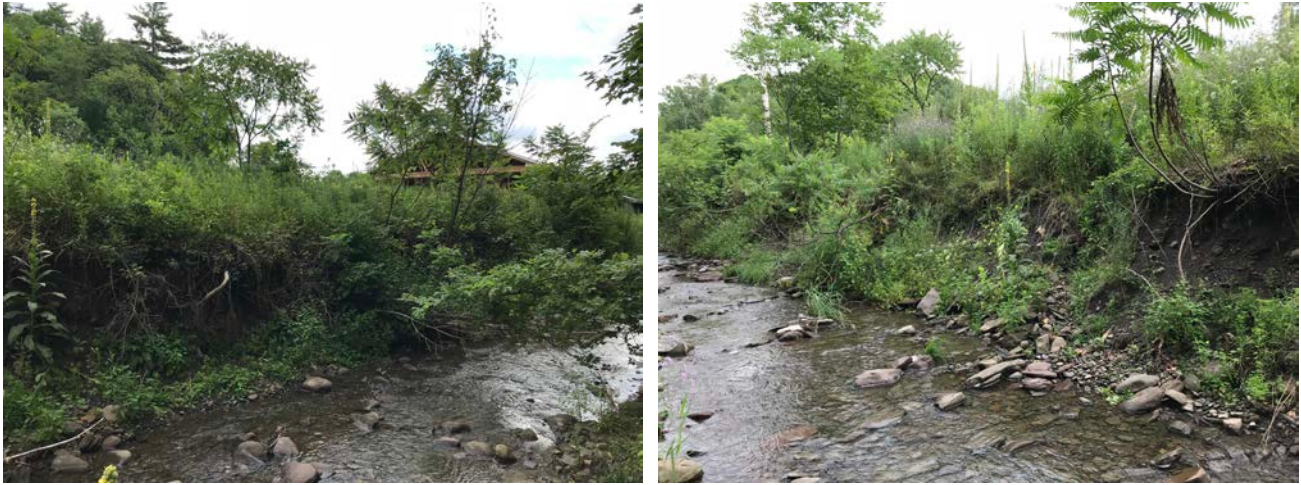
Dry Brook – Site 7

Site Observations – Channel is incised and entrenched through this entire reach. Some bank erosion is evident especially where riparian vegetation is limited. The upper segment of this reach has a slight floodplain bench along river right and trees protect the bank to the toe of the slope.

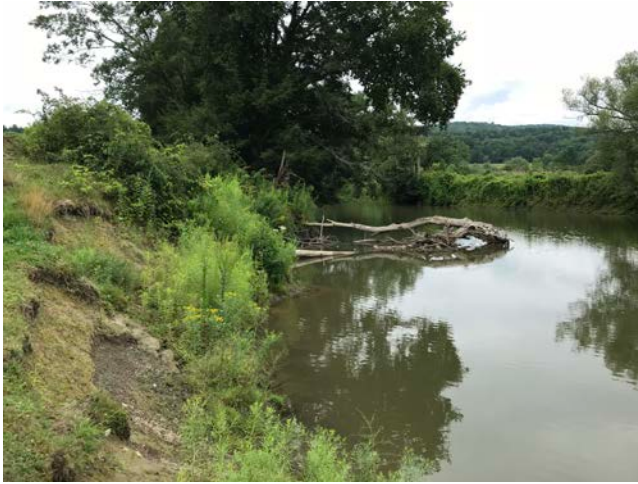
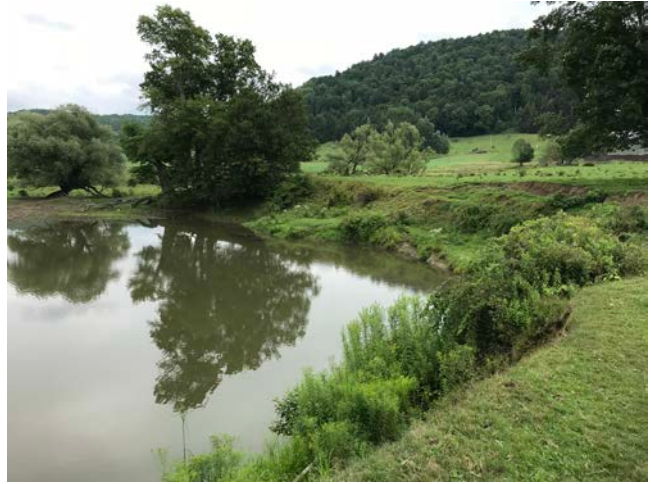
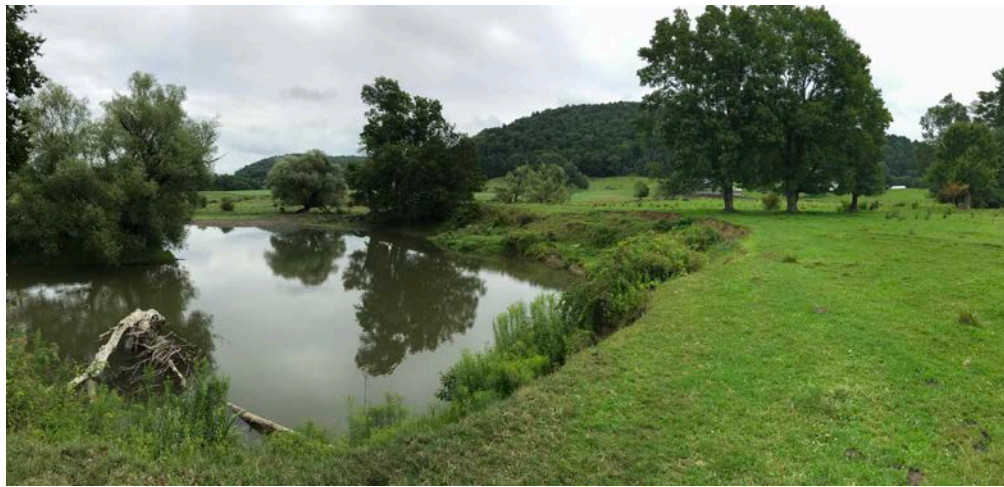
Butternut Creek – Haynes 1

Site Observations – Haynes site #1 is located within a pasture and the riparian vegetation consists mainly of perennial grasses. Cattle have uncontrolled access to the stream. The stream valley is extremely flat and a series of tortuous meanders are present. Site pictured above is approximately 300ft in length, however could be combined with a larger riparian buffer project.

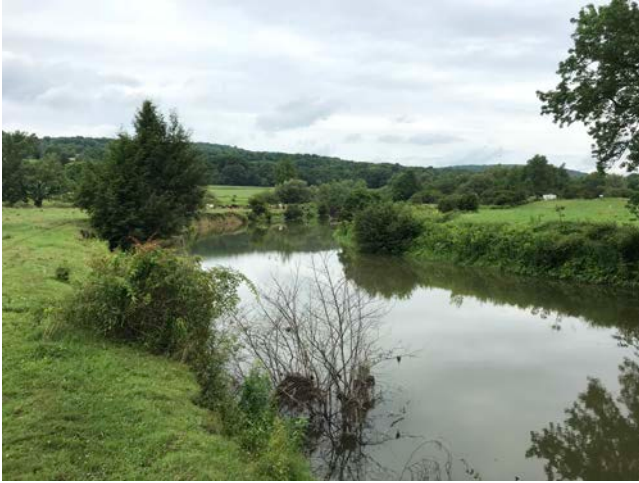
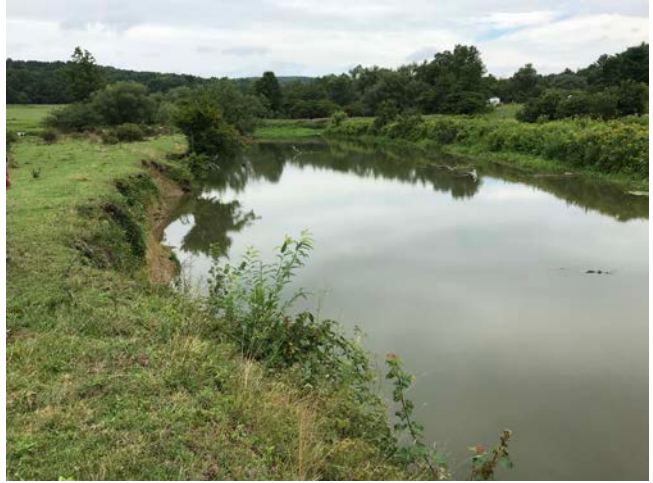
Butternut Creek – Haynes 2

Site Observations – The Haynes site #2 is a continuation of site #1 and should be considered as such when developing a remediation plan for this parcel. Again, cattle access to the stream and a lack of vegetation contribute to instability.

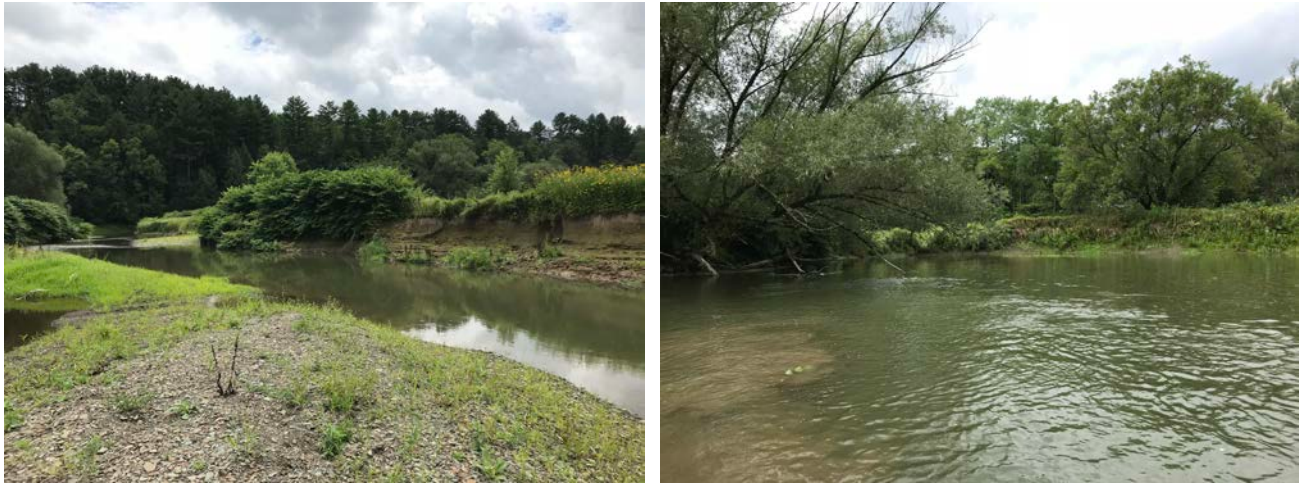
Butternut Creek – Birdsall

Site Observations – The streambank at this site consists of fine, easily erodible material and the riparian zone is dominated by Japanese Knotweed and grasses, both having shallow root systems. The affected bank is approximately 550ft in length and 6ft high. Site is becoming disconnected from its floodplain except during larger frequency events. Field adjacent to stream is mostly open, however, ground may remain fairly wet most of the year which could make access difficult.

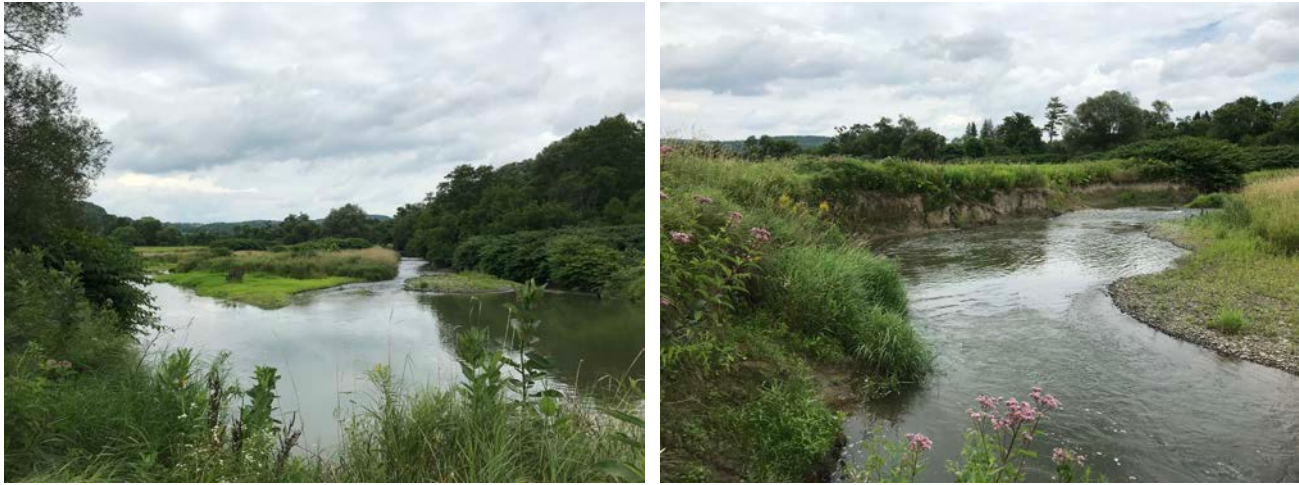
Butternut Creek – Lilley

Site Observations – This 400ft section of Butternut Creek is braided and some woody vegetation is starting to grow on the center bar. Areas up and downstream of this reach are fairly stable with forested buffers on right and left banks. Soils along the eroded right bank consist of sand/silt and are easily erodible especially as they are nearly vertical and lack vegetation at the toe of the slope. Site consists of mostly shallow riffles with short pools. Equipment access could be poor due to wet site conditions.

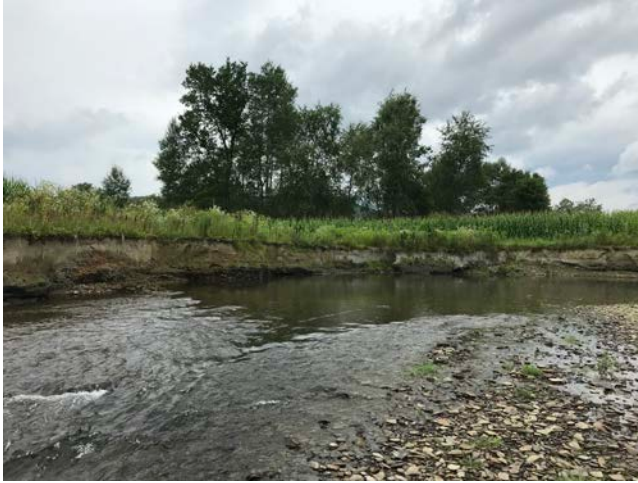
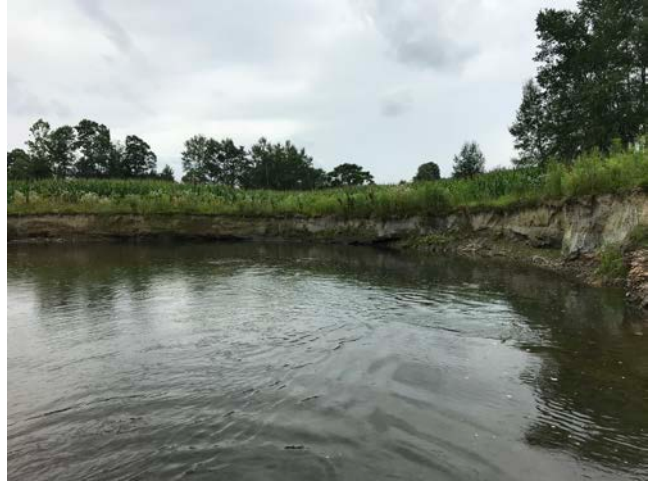
Butternut Creek – Morris School

Site Observations – This site occurs along an agricultural field planted right to the edge of the right bank. No woody vegetation with adequate root systems are present. Near bank stress is high, especially at the tight meander. Point bar formation along river left contributes to increased near bank stress along river right. Site is approximately 400ft in length with an 8ft high, vertical right bank. Soils are stratified and unconsolidated. Some evidence of riparian plantings, however, streambank needs to be stabilized to assure success of a buffer.

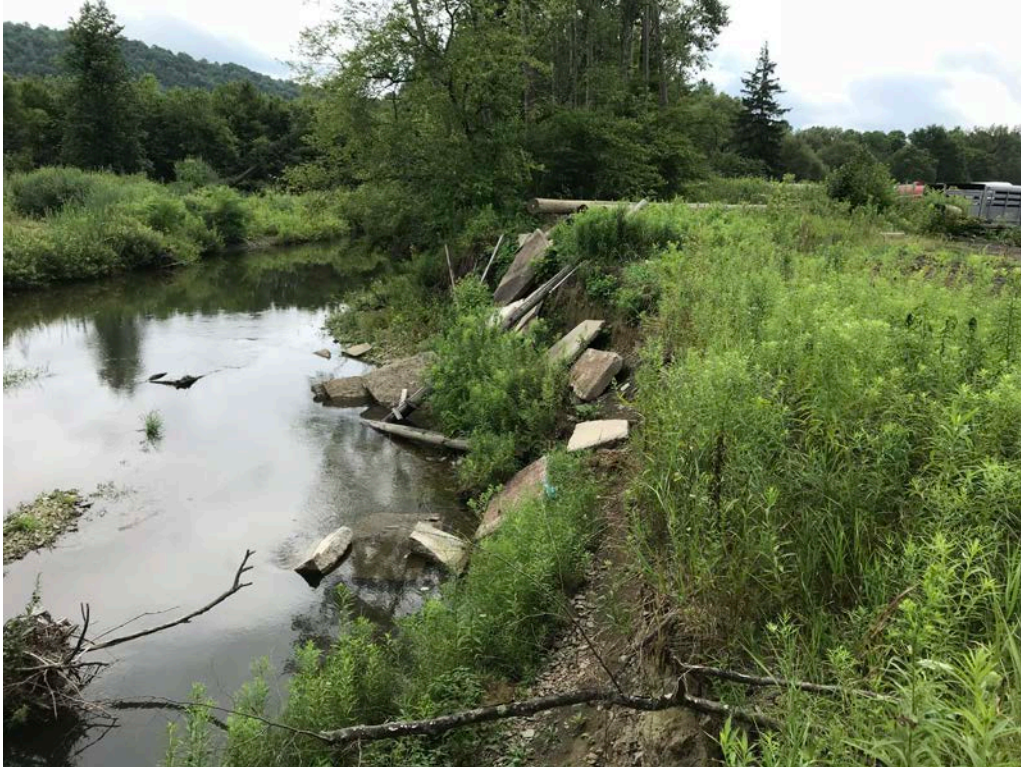
Butternut Creek – Morris Fairgrounds

Site Observations – This site occurs along the right bank adjacent to the Morris fairgrounds. It appears the tress were undermined and have fallen into the stream leaving a large scour pool and unstable bank. The site is approximately 150ft in length and 15ft high. It appears some attempt to stabilize the bank has been made by dumping concrete over the bank.

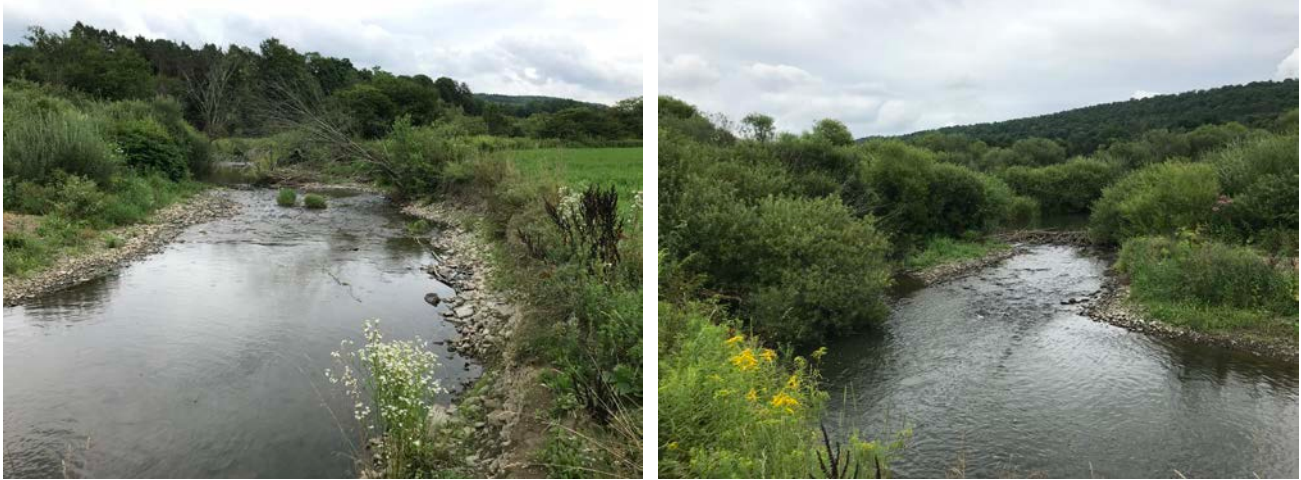
Butternut Creek – Galley 1

Site Observations – Generally speaking, the Butternut Creek (Galley) erosion sites (1 - 4) are similar in appearance and could benefit from similar remediation approaches. These sites are adjacent to row crop or hay fields with little to no woody riparian vegetation. Providing the near vertical banks with a more stable slope and installing structures to reduce shear stress along the toe of the slope would greatly reduce erosion and provide added stability throughout all 4 sections. Some areas where willows are taking hold along the toe of the slope appear to be stable and this approach should be mimicked throughout the affected reaches.
