Butternut Creek Watershed Assessment

Prepared for:
Upper Susquehanna Coalition
183 Corporate Drive
Owego, NY 13827
607.972.2348

By:
Otsego County Soil and Water Conservation District
967 County Hwy 33
Cooperstown, NY 13326
607.547.8337 Ext. 4

January 2021

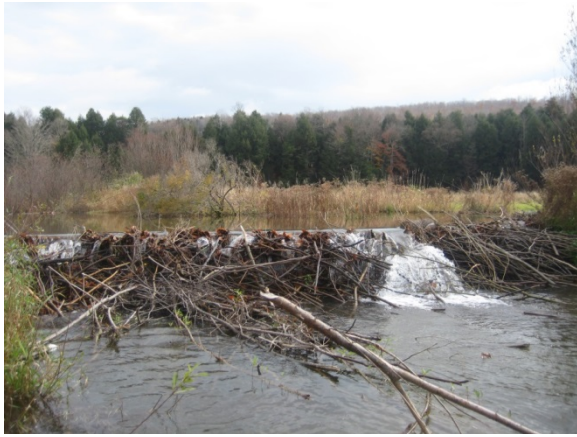
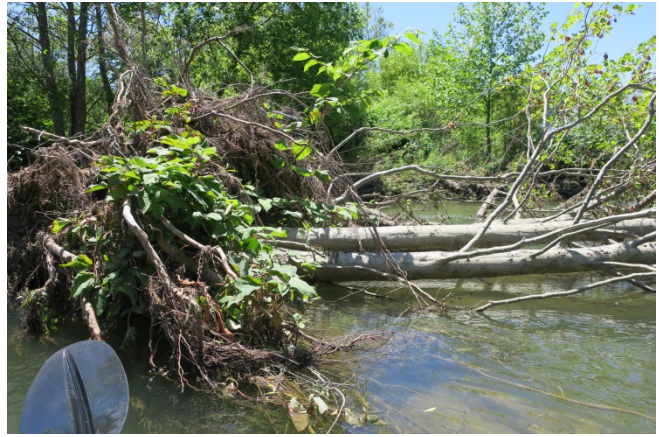
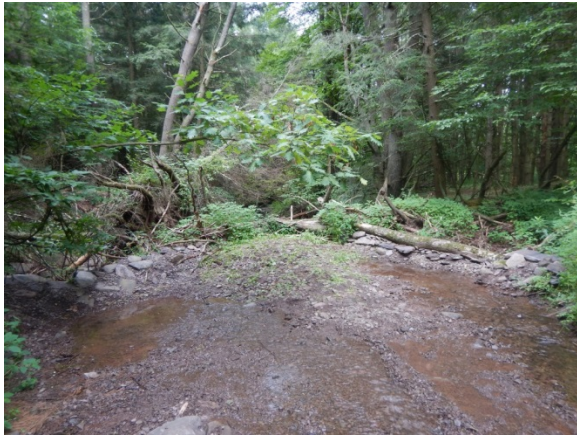
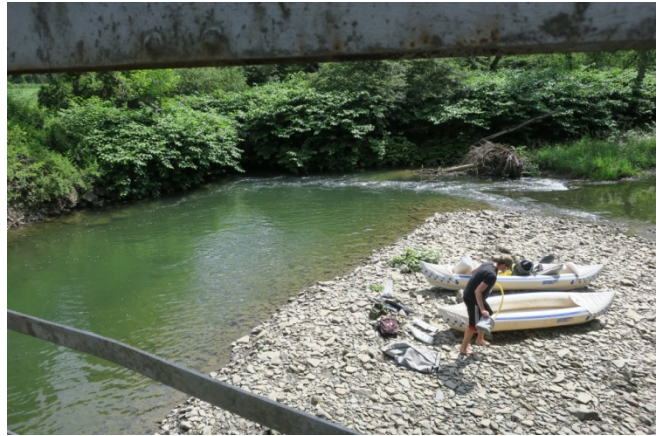
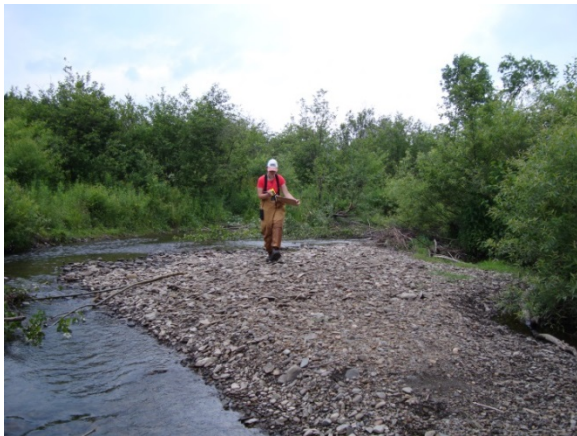
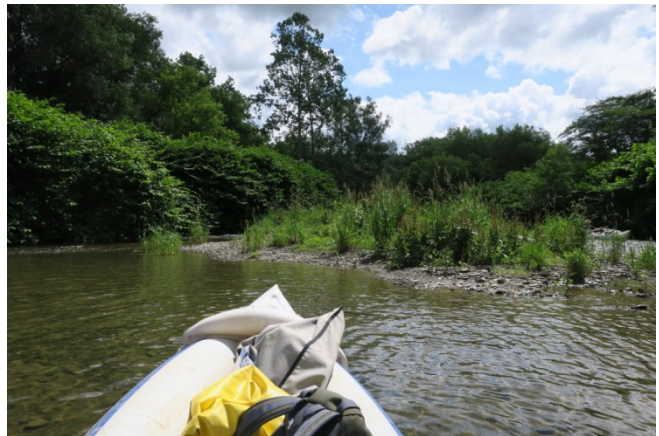
The most common depositional feature in the watershed was gravel bar (Table 5). Often there was large woody debris or smaller pieces of wood categorized as debris associated with the gravel bar. Frequently the bars were associated with erosion. Figure 11 provides examples of various depositional features found during the survey. Overall the Upper Butternut Creek watershed had the most deposition associated with the stream, followed by the Lower Butternut Creek watershed and then the Middle Butternut Creek watershed. In the Upper Butternut Creek watershed there were more depositional features on the mainstem compared to the tributaries whereas the Middle Butternut and Lower Butternut each had more depositional features associated with the tributaries compared to the mainstem. Looking at the watershed as a whole, the tributaries accounted for more than half of the depositional features mostly in the Gravel bar, LWD, or Gravel bar/LWD categories. The majority of observations noted depositional features but do not quantify the size of the features. A summary of observations for tributaries surveyed including deposition can be found in Appendix F. Figures 12, 13, and 14 show the distribution of deposition sites in the Upper Butternut, Middle Butternut, and Lower Butternut Creek watersheds respectively.

Figure 11. Upper Left: Beaver dam on the mainstem Butternut in Upper Butternut Creek (Photo: Ed Lentz, 10/30/2016), Upper Right: Large woody debris on the mainstem Butternut in Middle Butternut Creek (Photo: Les Hasbargen, 6/14/2017), Middle Left: Gravel bar and debris in Shaw Brook (Photo: Maggie Brenner and Tom Washbon, 7/27/2018). Middle Right: Gravel bar upstream of Peet Rd bridge Middle Butternut Creek mainstem (Photo: Les Hasbargen, 6/28/2017). Lower Left: Gravel bar on the Upper Butternut Creek Mainstem (Photo: OCSWCD, 6/30/2017), Lower Right: Mid channel bar with vegetation on the Middle Butternut Creek mainstem (Photo: Les Hasbargen, 6/28/2017).

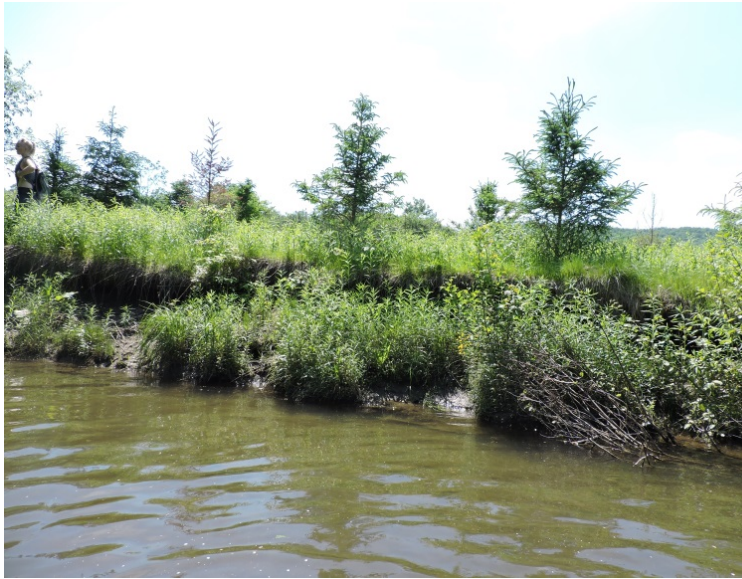
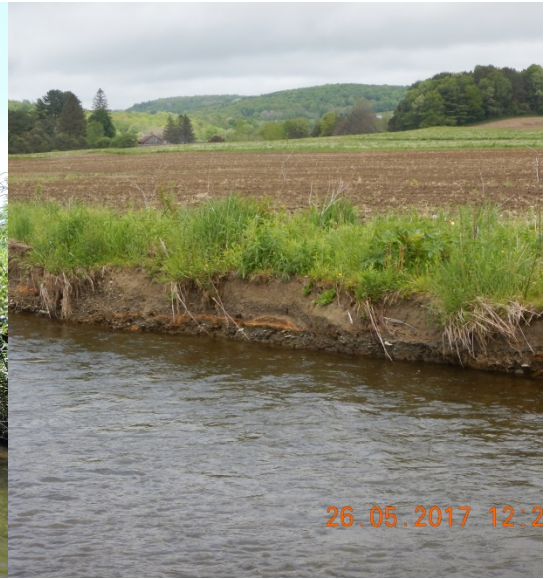
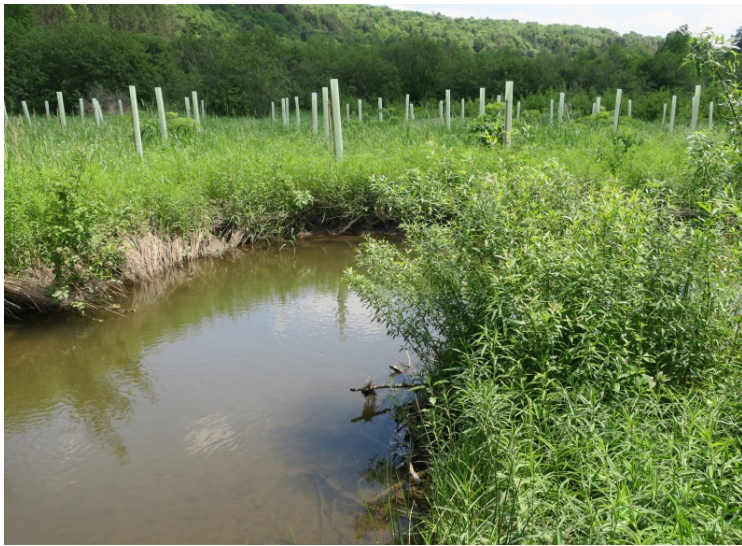
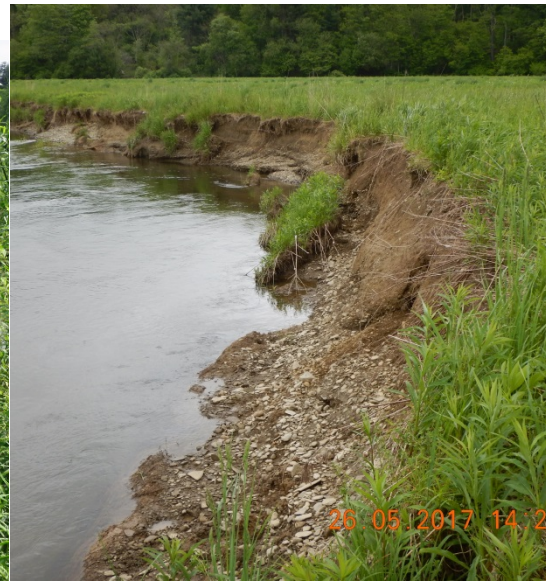
Figure 15. Upper Right: Narrow band of recently planted trees in riparian buffer on the mainstem Butternut Creek in the Upper Butternut Creek watershed (Photo: OCSWCD, 6/12/17). Upper Right and Lower right: Lack of riparian vegetation on the mainstem Butternut Creek in the Middle Butternut Creek watershed (Photos: Ed Lentz, 5/26/2017), Lower Left – Recent Trees for Tributaries planting on the mainstem Butternut in the Upper butternut (Photos: Les Hasbargen, 6/12/17).

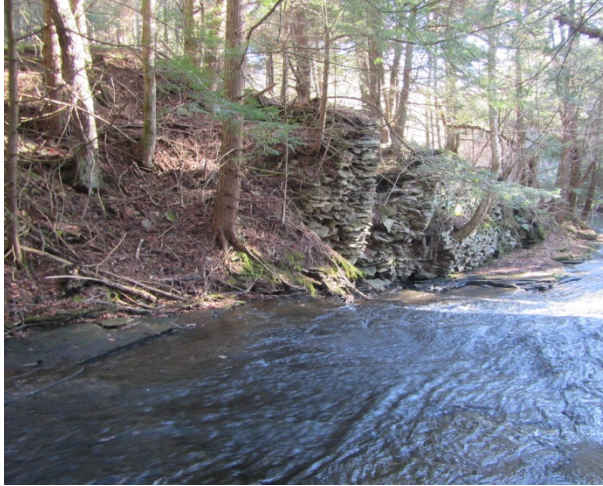
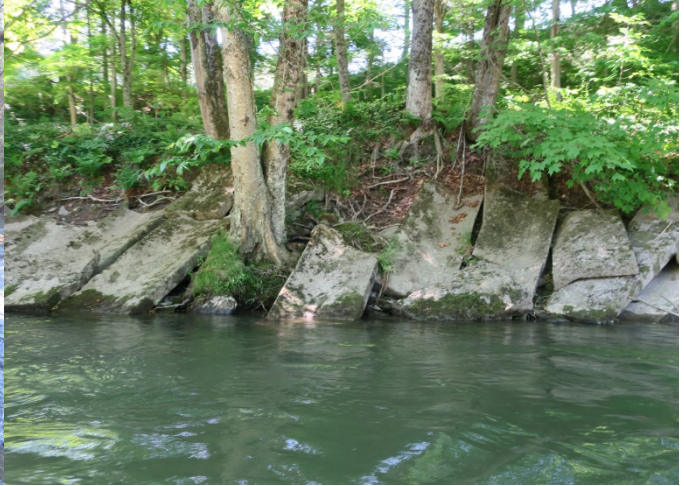
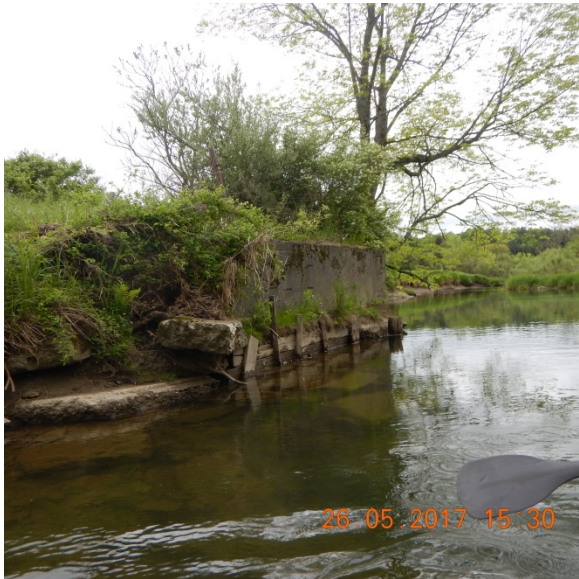
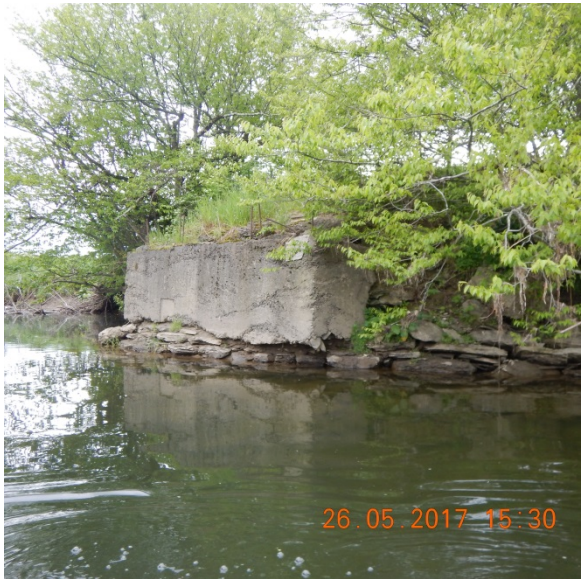
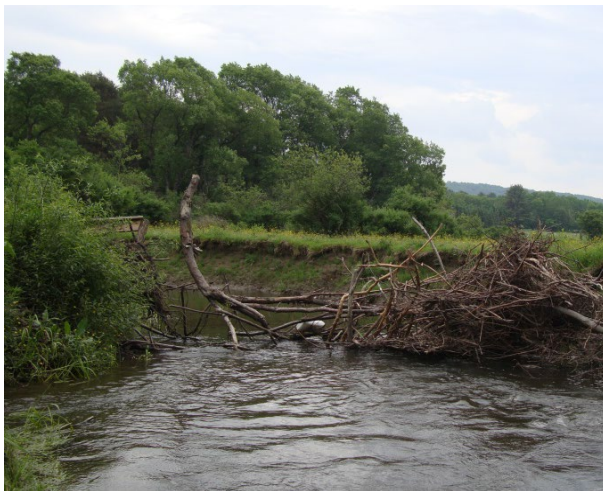
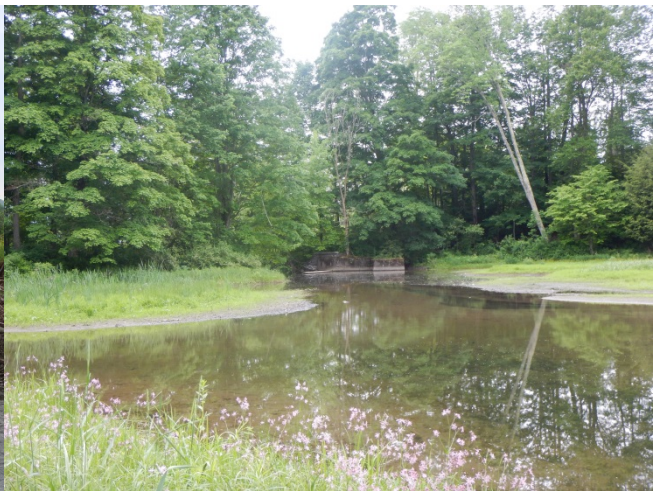
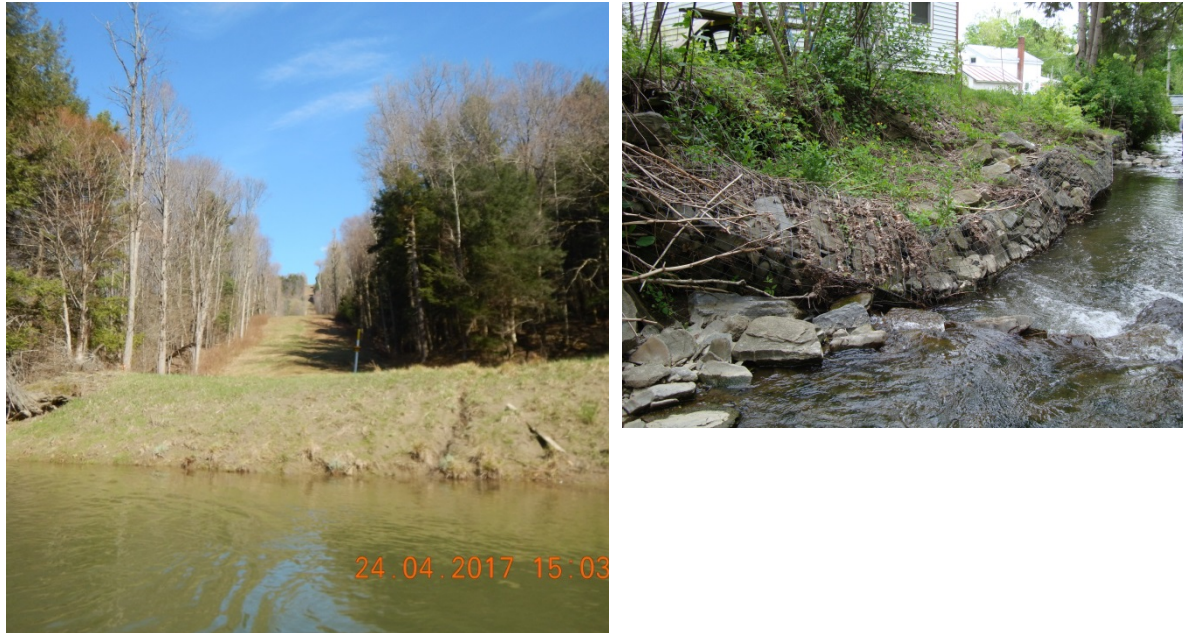
Figure 19 continued

Figure 19. Upper Left: Old dam remnants on Silver Creek (Photo: Ed Lentz, 11/08/2017), Upper Right: Rock rip rap on the mainstem Butternut Creek in the Middle Butternut Creek watershed (Photo: Les Hasbargen, 6/14/2017), Middle Upper Left and Upper Right: Old bridge abutments, left bank and right bank, on the mainstem in the Middle Butternut Creek watershed (Photo: Ed Lentz, 5/26/2017), Middle Lower Left: Fencing across stream with debris caught in it on the mainstem Butternut Creek in the Upper Butternut Creek watershed (Photo: OCSWCD), Middle Lower Right: Dam on Morris Brook (Photo: Ed Lentz, 6/3/2018), Lower Left: Gas pipeline right of way on the Lower Butternut Creek mainstem (Photo: Ed Lentz, 4/24/17). Lower Right: Gabion Baskets with erosion on Reservoir/Silver Brook in the Village of Morris (Photo: OCSWCD, 5/21/2017).

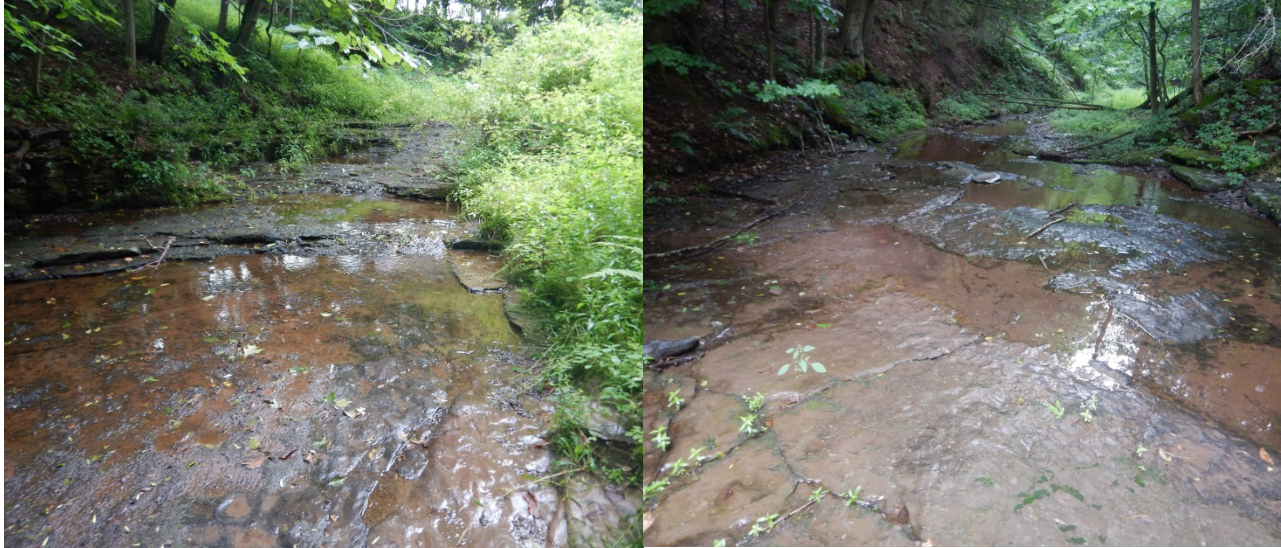
Bedrock was minimally recorded despite presence in the watershed. There were 34 observations recorded of bedrock in the watershed, 32 of which were in tributaries. This is not a comprehensive summary of the presence of bedrock in the watershed. Examples of bedrock observed during the survey can be found in Figure 24.

Figure 24. Examples of bedrock observed in Shaw Brook (Photos: OCSWCD, 8/1/2018).

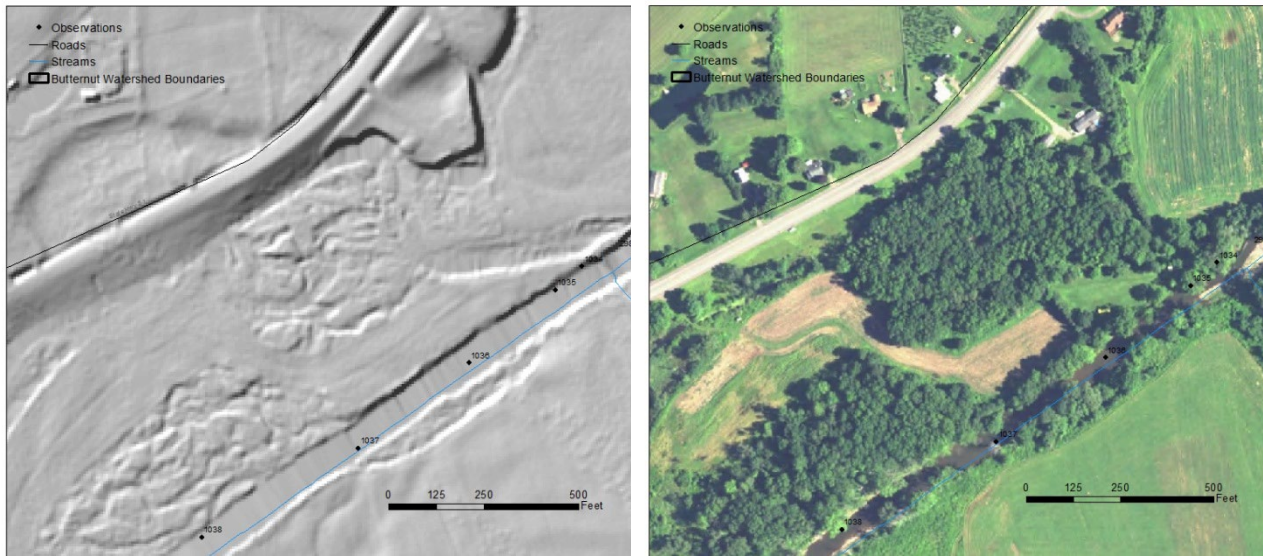
Figure 27. Area of floodplain access potential in the Lower Butternut Creek watershed. Left: LiDAR surface model 2012, Right: Aerial imagery NAIP 2015.

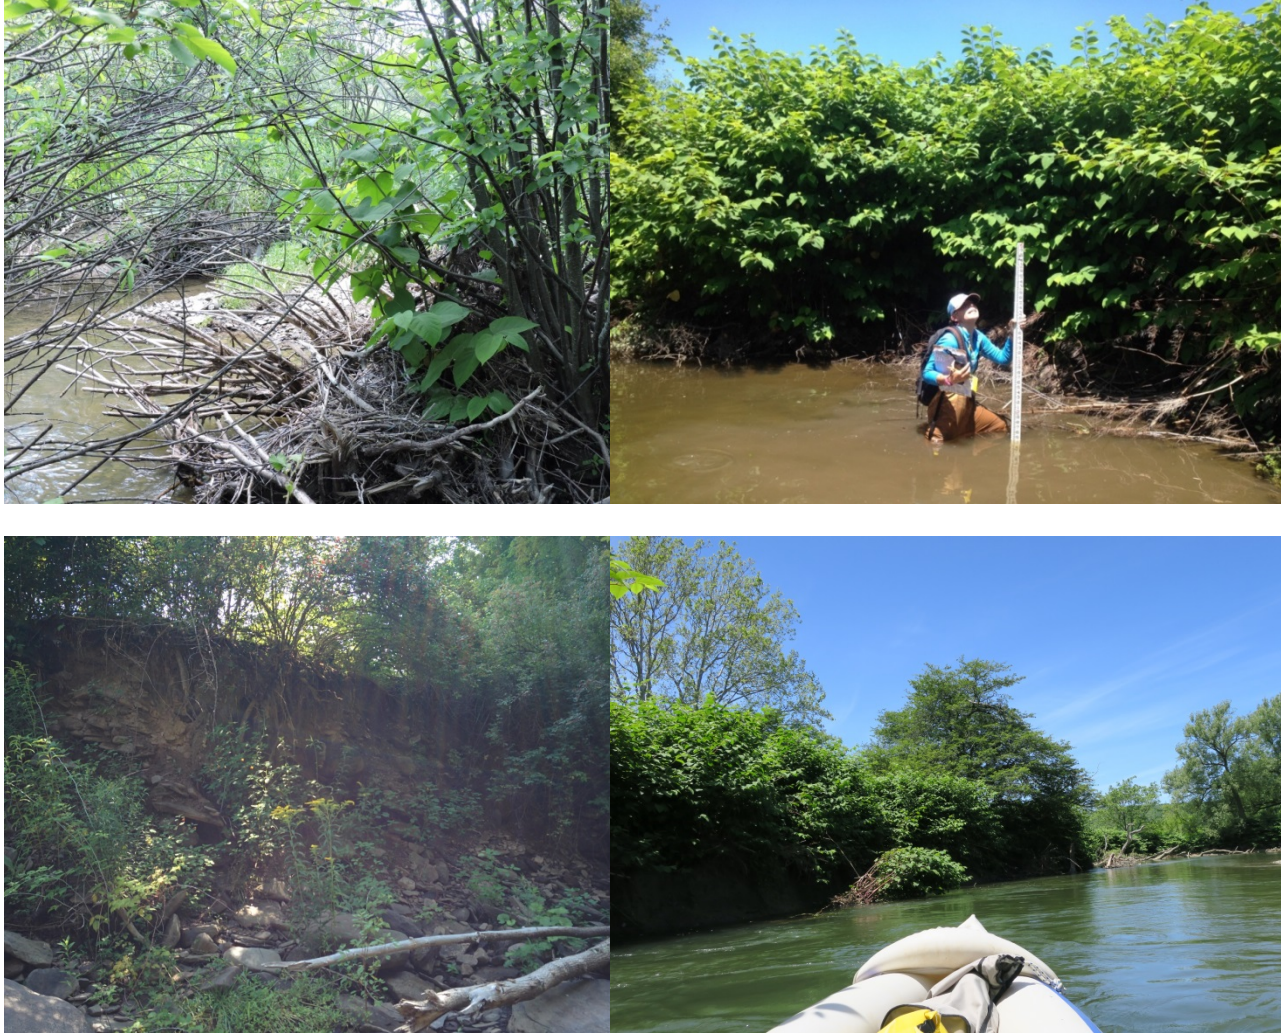
Figure 28. Upper Left: Small patch of knotweed on the mainstem Butternut Creek in the Upper Butternut watershed (Photo: OCSWCD, 6/12/17), Upper Right: Knotweed on the mainstem Butternut Creek in the Upper Butternut watershed (Photo: OCSWCD, 7/19/17), Lower Left: Multiflora rose overhanging bank on Cahoon Creek (Tom Washbon and Maggie Brenner, Photo: 8/6/2018), Lower Right: Extensive knotweed with large chunk falling in stream on the mainstem Butternut Creek in the Middle Butternut Creek watershed (Photo: Les Hasbargen, 6/14/17).

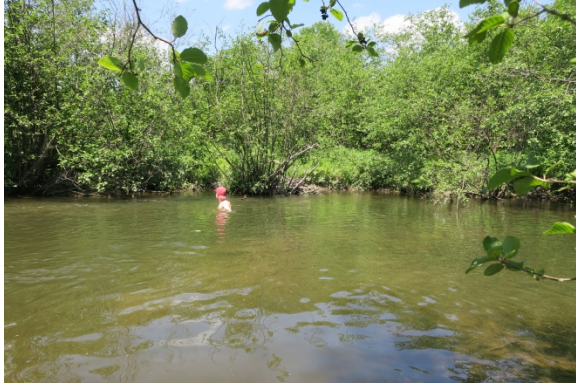
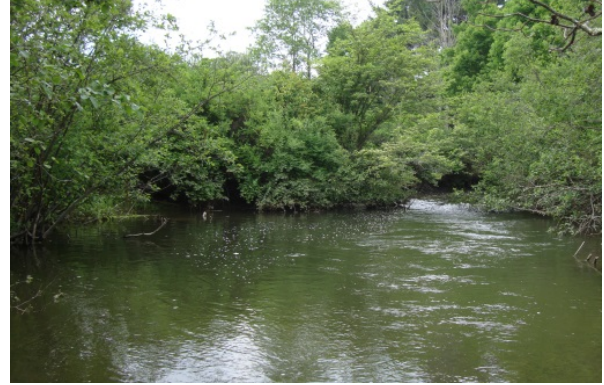
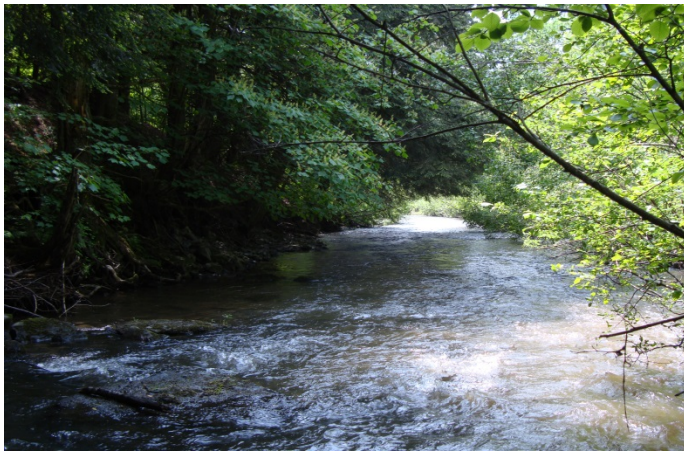
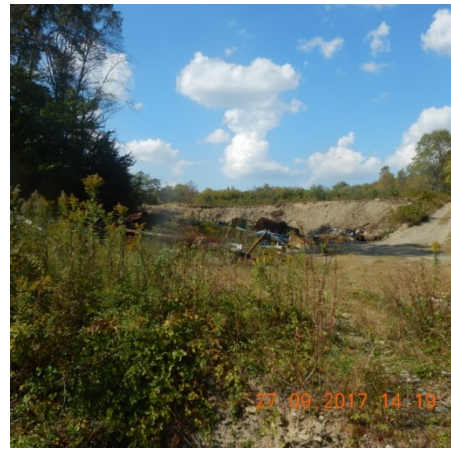
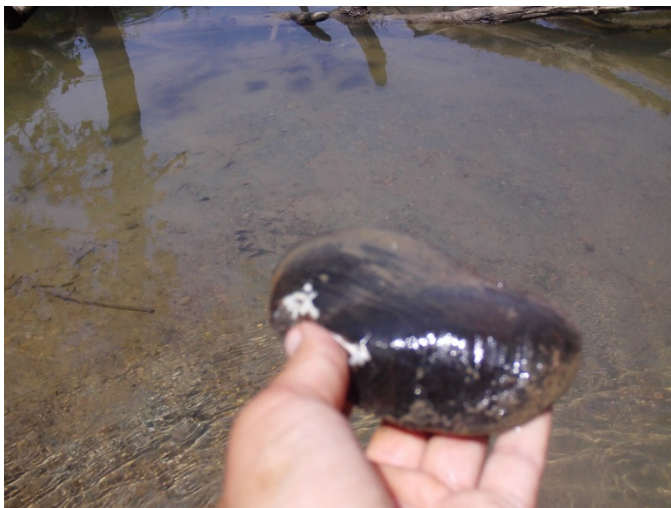
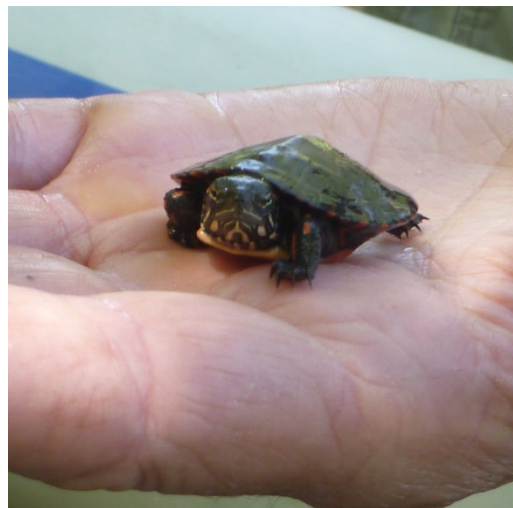
Figure 32. Upper Left – Nice deep pool with riparian cover on the mainstem in the Upper Butternut Creek watershed (Photo: Les Hasbargen, 6/12/17), Upper Right: Nice deep pool with riparian cover on the mainstem in the Upper Butternut Creek watershed (Photo: OCSWCD, 6/12/17), Middle Left: Nice riparian cover on mainstem in the Upper Butternut Creek watershed (Photo: OCSWCD, 6/12/17), Middle Right: Garbage and gravel mine on Stony Creek (Photo: Ed Lentz, 9/27/17), Lower Left: Freshwater mussel found on the mainstem Butternut Creek in the Lower Butternut Creek watershed, species needs to be verified (Photo: OCSWCD, 8/9/2017), Lower Right: Painted turtle found in the mainstem Butternut Creek in the Middle Butternut Creek watershed (Photo: Les Hasbargen, 6/14/17).

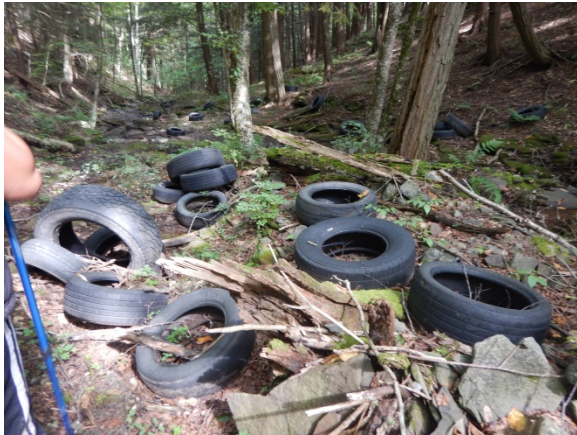
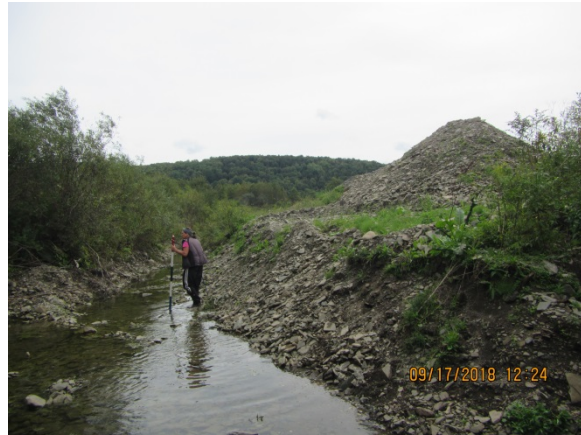
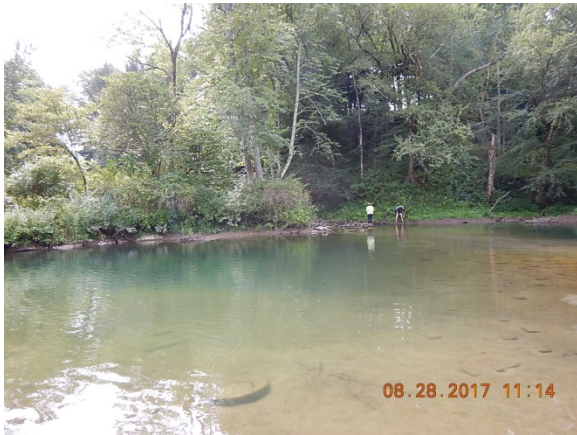
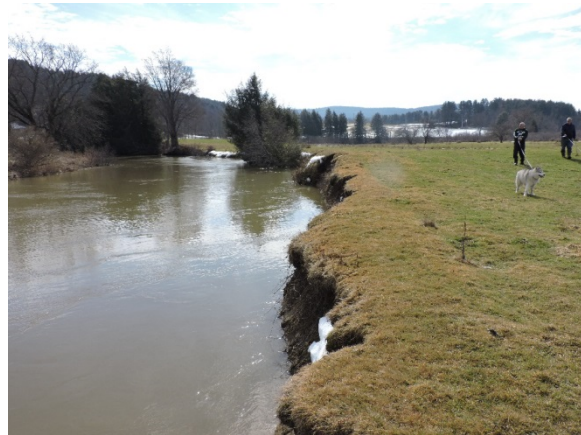
Figure 36. Significant Features: Upper Left: Tires in Shaw Brook (Photo: Maggie Brenner and Tom Washbon, 9/7/2018), Upper Right: Dredging on Harris Brook (Photo: Maggie Brenner and Tom Washbon, 9/17/2018), Lower Left: Cold water pool on mainstem Butternut Creek in Lower Butternut Creek watershed (Photo: OCSWCD, 8/28/2017), Lower Right: Erosion on mainstem Butternut Creek in Lower Butternut Creek Watershed (Photo: OCSWCD, 2/4/2018).

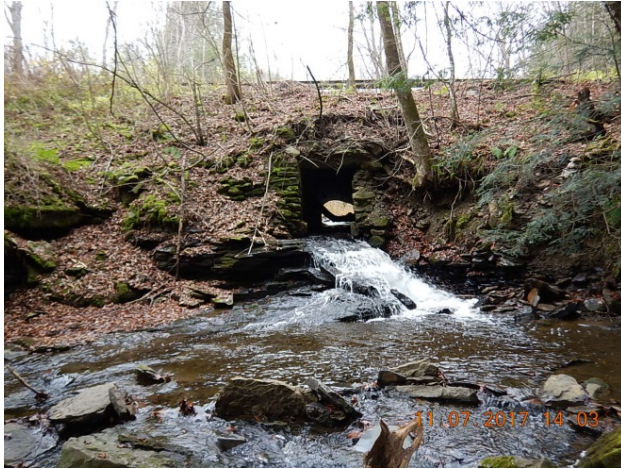
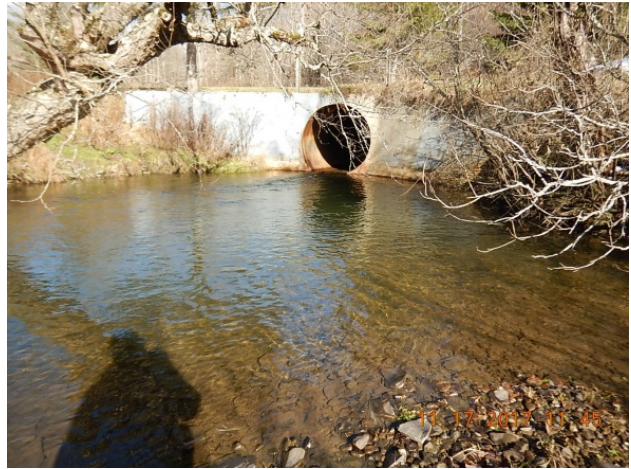
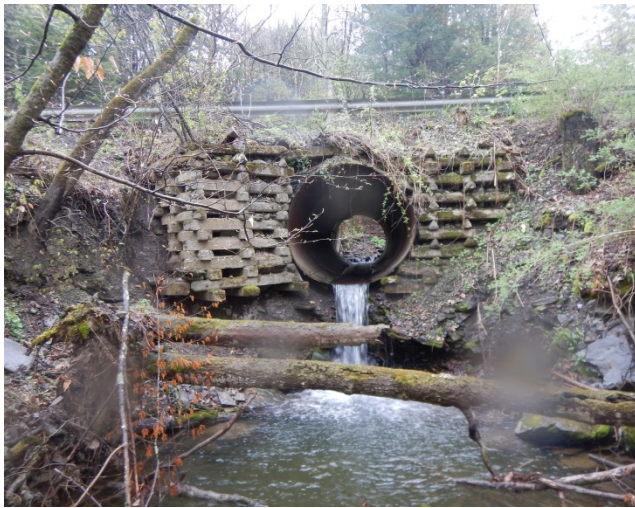
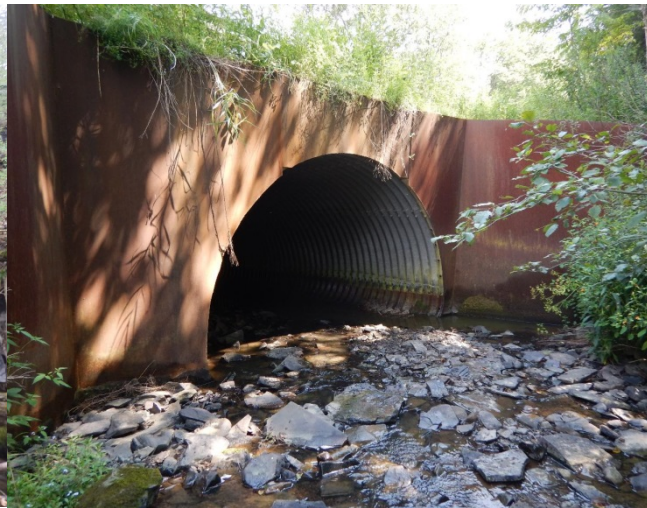
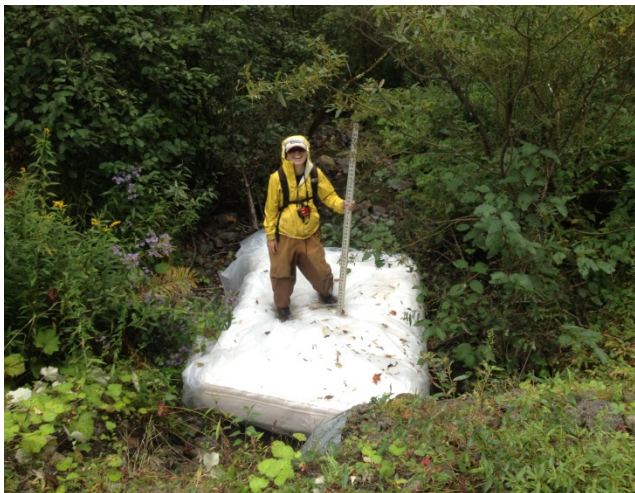
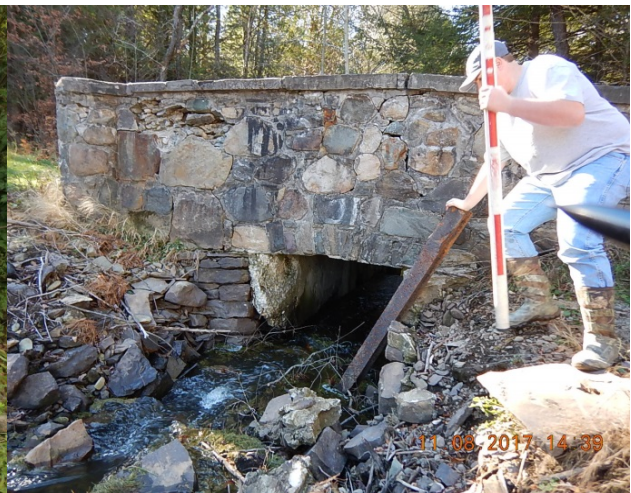
Figure 38. Stream Crossings - Upper Left: Narrow culvert on Stony Creek (Photo: OCSWCD, 11/7/17), Upper Right: Culvert with large scour pool on Calhoun Creek (Photo: OCSWCD, 11/17/17), Middle Left: Culvert with large drop and scour pool on Fairview Creek (Photo: Tom Washbon and Maggie Brenner, 5/12/2018), Middle Right: Culvert on Morris Brook (Photo: OCSWCD, 8/7/2018), Lower Left: Culvert on unnamed tributary – UB_014 with debris at outlet (Photo: OCSWCD, 9/8/2017), Lower Right: Culvert on tributary to Stony Creek (Photo: OCSWCD, 11/8/2018).
